THERMOSTAT ISSUES AND SELECTION, for Silver Shadows (SY), Silver Spurs (SZ) and their Derivatives

Don Elliott and Phil Birkeland, (WA) and Brian Vogel, (VA)
With contributions from Bill Coburn, RROC-A, Canberra, Australia

April 2012

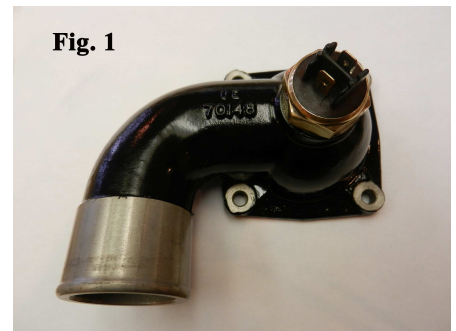
The interest in this subject was prompted by the low reading shown on the temperature gauge of my 1988 Silver Spur (NAJ-24409). Other than the ominous red band at the top of the scale, my temperature gauge has no tick marks, white bands, numbers, or any other markings that would facilitate a repeatable monitoring of the temperature. But it just seemed to be consistently low. Therefore, I used an infra-red (IR) temperature sensor¹ to check the temperature on top of the thermostat housing shown in Fig. 1. See TSD4700 Chapter L (for the Silver Spur) for more information.

If the testing showed the engine to be at a normal operating temperature, this project would have been diverted to addressing temperature gauge or sensor malfunctions, but the measurement showed that the engine was operating at ~186°F when fully hot. For this car, the manual states that the thermostat will begin to open at ~190°F and will be fully open in maximum cooling mode when the temperature reaches ~210°F. This is fairly typical for a so-called "modern" car. Temperatures significantly below (or above) this number when the car is fully warmed up could mean that the thermostat is acting up. Therefore, my engine was running ~10°F too low and an investigation into its thermostat condition was launched.

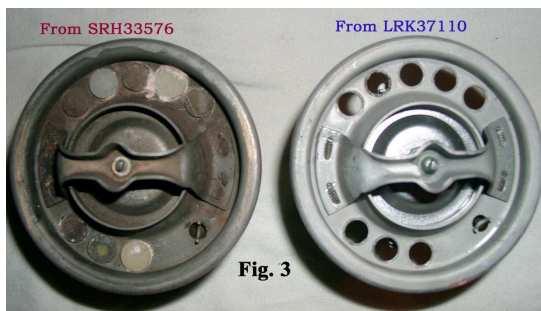
The original thermostat for the SY and SZ cars (UE36600) has eight holes that were intentionally plugged off with a low melting point solder as discussed in Section B. These lead plugs have been found to be missing in some early Spurs thus causing the thermostat to become ineffective. Fig. 3 shows two UE36600 thermostats. The thermostat shown on the left is

from Brian Vogel's 1978 Silver Shadow II, SRH33576 and the one on the right is from a 1979 Silver Wraith II, LRK37110. The thermostat on the left shows an undamaged, but quite soiled thermostat. The solder plugs are still in place and the performance was in the middle of the normal temperature range. The thermostat on the right is missing its solder plugs which MIGHT indicate that it has been overheated; however, it is remarkably clean with no distortion or discoloration that might indicate such an event. Certainly there is no residual melted product remaining around the holes, and it is quite significant that this thermostat still opens and closes normally. Clearly it was not "stuck shut". These facts add to the doubt of it being subjected to an overheating event.

A similar thermostat was removed from my 1988 Silver Spur. While its lead plugs were still in place, all lead surfaces were found to have been subjected to some sort of corrosive attack. Portions of the plugs were pockmarked, were "furry" in appearance, and flaked away easily if touched. It was obvious that they were failing. My experience in the chemical process industry is that lead alloys are commonly affected by cold flow, cracking, poor adherence, and odd corrosion issues. Therefore, the actual mechanism of failure of Brian's lead plugs may well be something other than simple overheating.

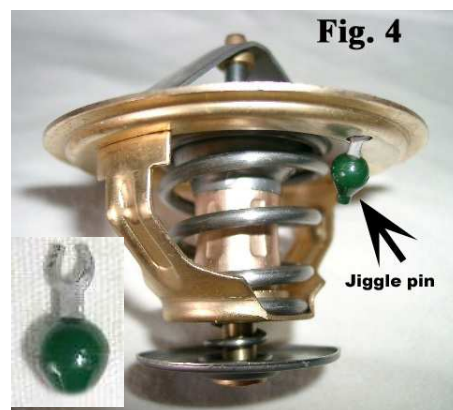
The Stant 13558 has an overall flange diameter of 67mm and the UE and PG dimension is 69mm. This difference is insignificant as both the Stant and the two Crewe designs rest comfortably in the counterbore of the engine. Once the upper housing and gasket are replaced, the thermostat is immobilized in place. Another difference is the lack of ability for air to escape from under the Stant thermostat when the system is refilled. To rectify this omission, Brian salvaged the jiggle pin from his scrap UE thermostat and adapted it to his new Stant #13558 as shown in Fig. 4. He recommends drilling a 3/16” hole and removing the burrs underneath. Doing so takes about five minutes. Inserting the jiggle pin and spreading the U-shaped arms of the pin holds it in place. Rounding the bottom of the plastic bulb to a near spherical shape (see Fig. 4 insert) minimizes the risk of it becoming trapped in the mechanism thereby jamming the thermostat open. Drilling a smaller hole (~3/32” or so) in the skirt will also provide an air vent without using the pin. Having a jiggle pin is likely a better solution since it will keep the hole clear of debris and the float will minimize the leakage past the thermostat.

Stant (non-Crewe thermostats) have been operating normally at the proper operating temperatures since September 2011 in Brian Vogel's Silver Shadow II (SRH33576) and since January in his Silver Wraith II (LRK37110) and my 1988 Silver Spur (NAJ-24409). With their 8% greater open area design (Appendix A), summertime operation is expected to be improved.

- It is recommended that an air vent be provided if the Stant thermostats are used. Transplanting the jiggle pin assembly from another thermostat is the preferred technique. A small hole drilled in the skirt would also work.
